E570 report

2005/11/15 S.Okada

1 Inspection of SDDs

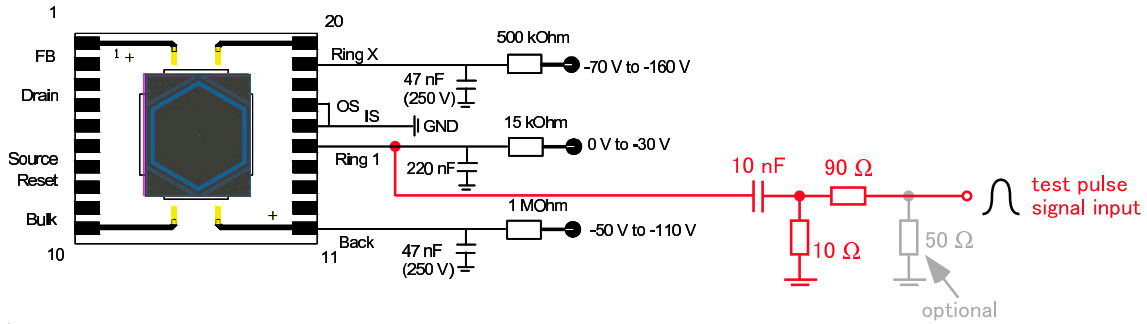
Figure 1: Circuit schematic of test pulse input for "Ring 1"

In the last meeting, we have discussed about monitoring test pulse at the preamp in order to monitor the SDD gain stability during data taking. Unfortunately there was no test input in our preamp according to the persons in charge of the SDD in KETEK. Instead, they recommended us to add a test input line for Ring1 as follows. (They have already performed such a test input line at another SDD products.) In this case, it will be possible to monitor the gain stability not only from preamp but SDD itself.

Of course, we must be check whether the test line deteriorate the energy resolution or not. It will be checked also at SMI side from next week.

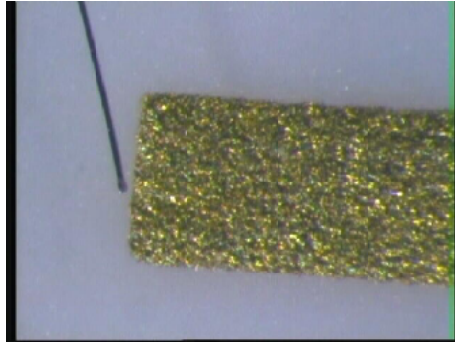
In SMI, we checked these SDDs by microscope and took the pictures. The magnified pictures for each parts are shown in page #4. We found that "RingX" wire of SDD #1 is detached (see page #5).

SDD #1 : "Ring X" wire has been detached.

In KETEK, they checked all the SDDs and found that SDD #8 had bad contact at "last ring" bonding which could not be seen by microscope. The wire re-bonding and the operation check for SDD #1, #7 and #8 have been done during my stay at Munich. So I brought back these repaired SDDs (#1, #7, #8) and newly ordered five SDDs. Now we have 11 available SDDs !!

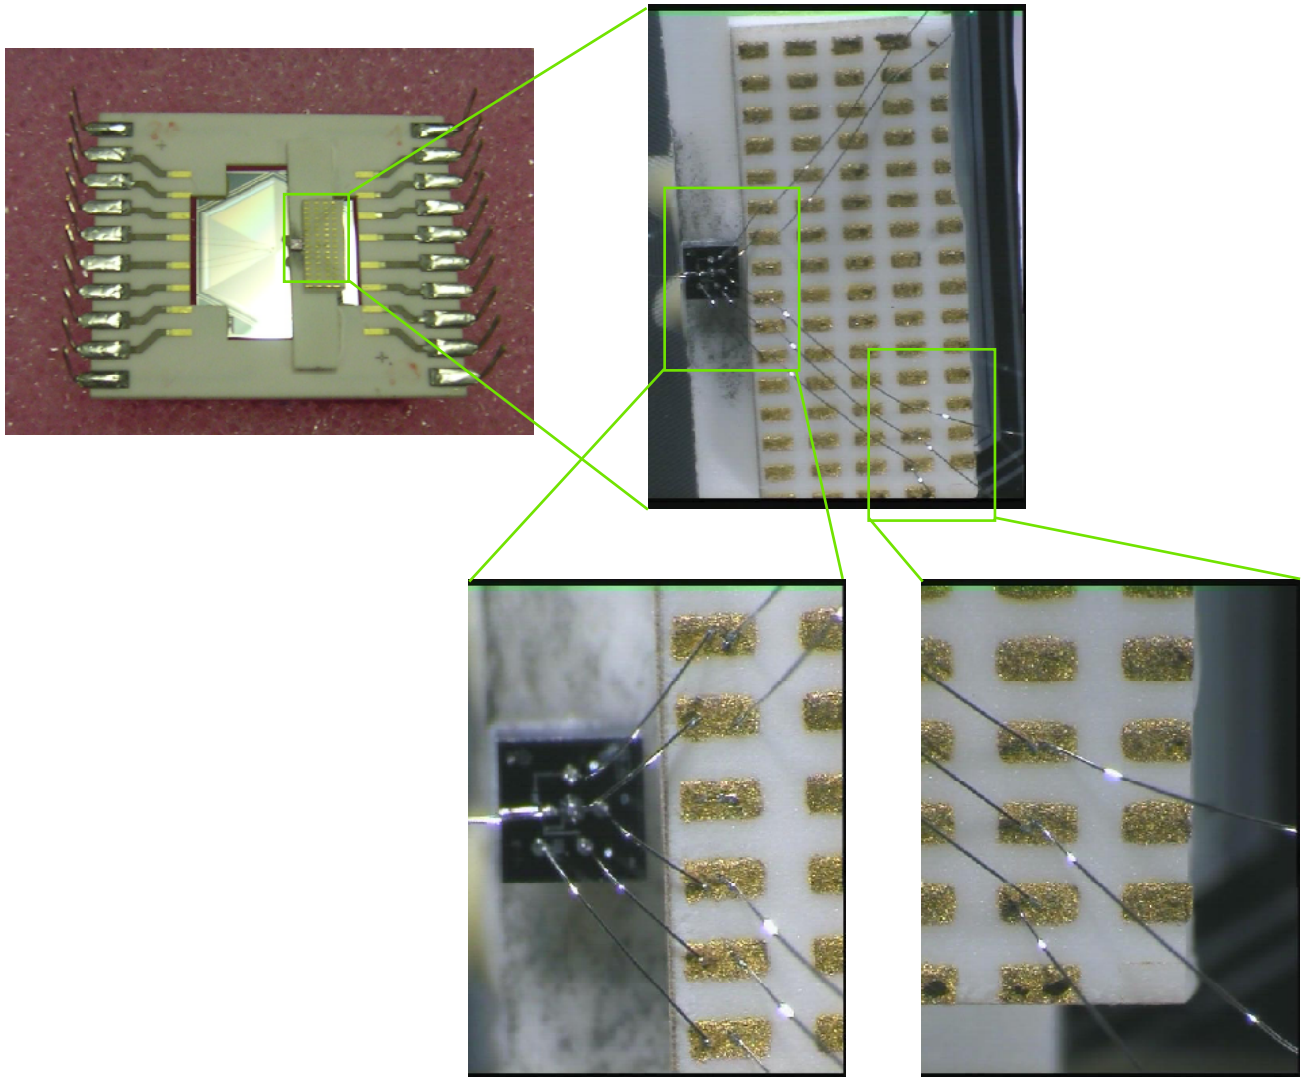
SDD#3 : having bad resolution probably due to replacing the FET. (see page #5)

SDD #3 : having bad resolution

The FET of SDD #3 has been replaced by KETEK and the wires were connected to side connector pins through additional ceramic board as follows.

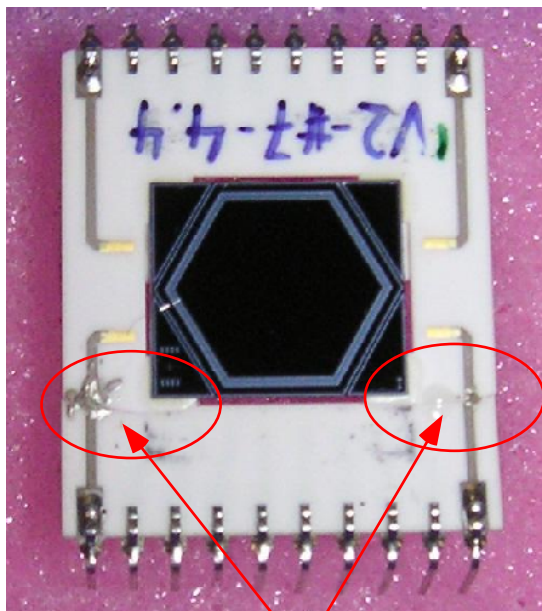
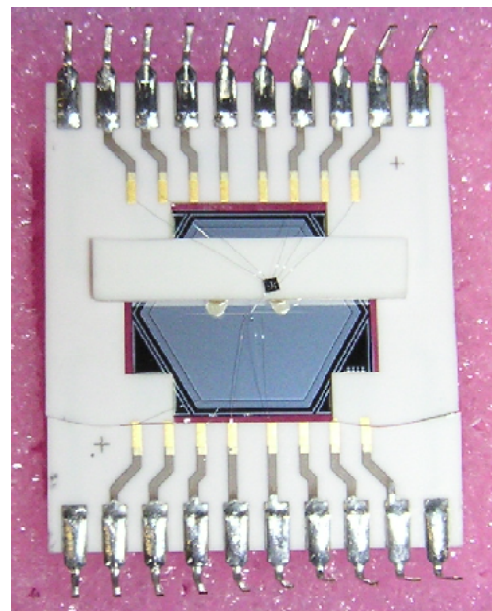
SDD#6 : ceramic board cracking for two parts (see page #6)

SDD #6 : cracked the ceramic board

cracking

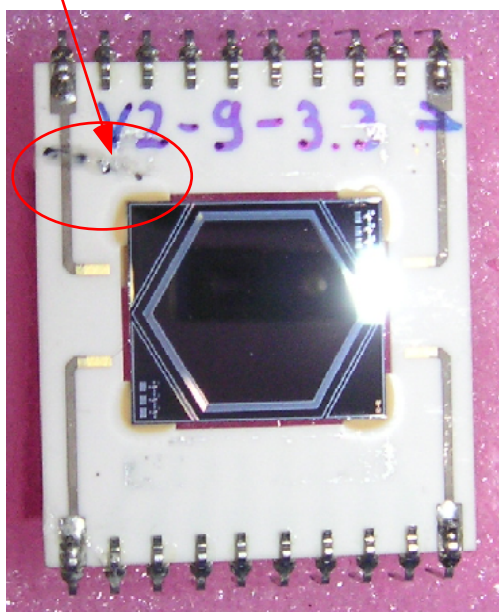
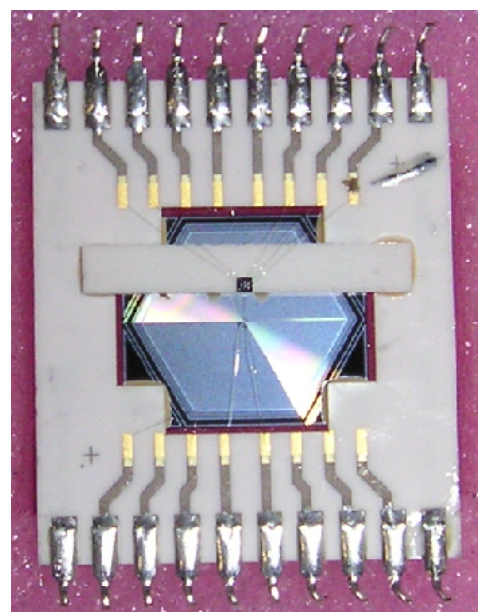
SDD#7 : ceramic board cracking for one parts (see page #6)

SDD #7 : cracked the ceramic board

cracking

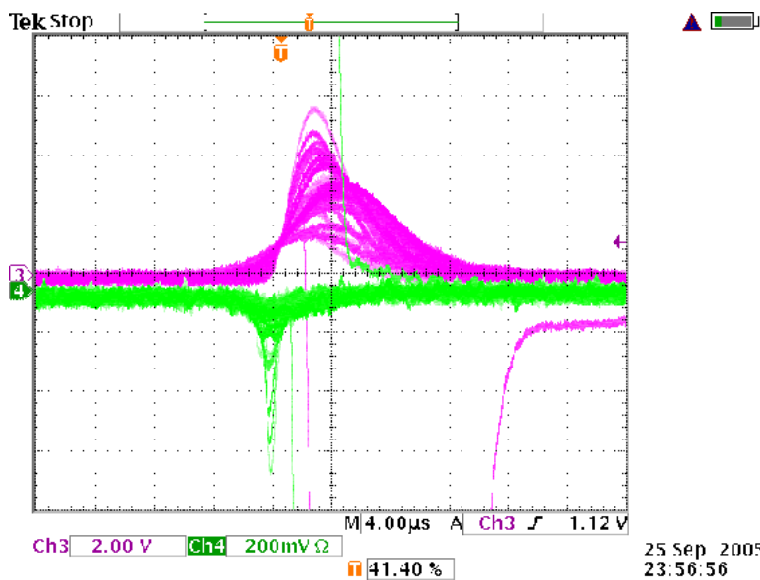
@ KEK (before the beamtime)

SDD#8 : In ^{55}Fe source calibration, the signal shape was not like x-ray from ^{55}Fe . (see page #7)

The typical pulse shape in the ^{55}Fe source calibration is shown in the following pictures. These pulses are outputs from the shaping amp "CAEN N568BD" for 3 μsec (CH3) and 0.2 μsec (CH4) shaping time.

The pulse height was continuous, which is not like x-ray from ^{55}Fe . Furthermore there were two types of width.

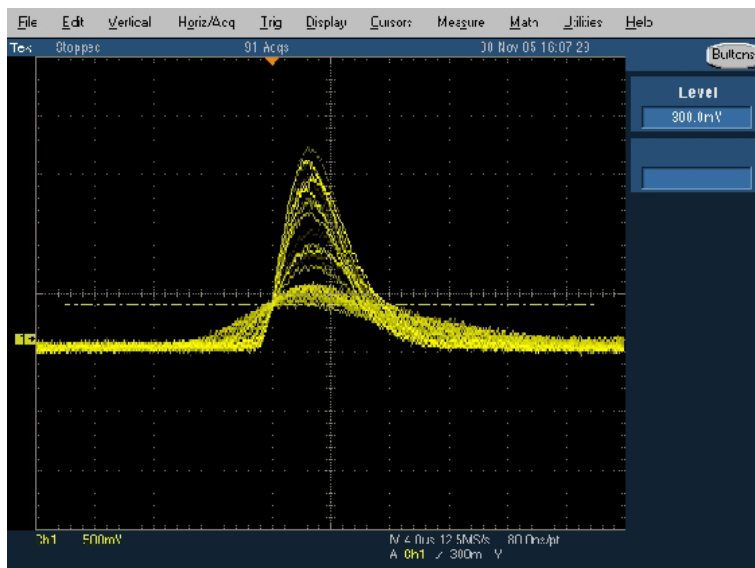
@ SMI (2005/11/08)

To confirm that the SDD #8 was really broken before going to KETEK for inspection, we checked the signal again in SMI. The signal was reproduced as follows.
